A SILENT PERFORMANCE AT CARNEGIE HALL

The client insisted that the new air-conditioning system for the acoustically and visually splendid hall be noiseless and invisible. The engineers complied.

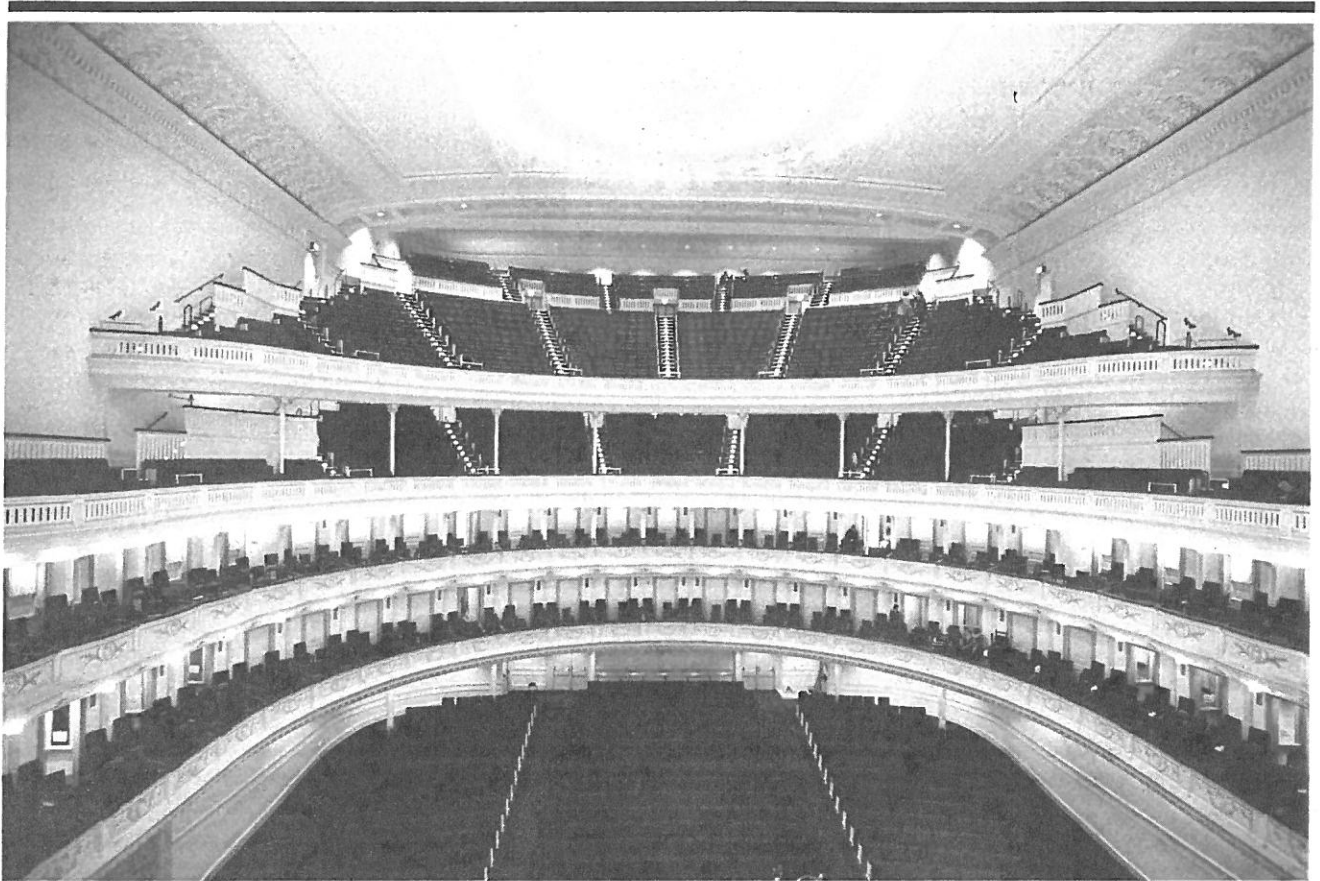
Air-delivery troffers and the large ducts they require are concealed in the ceiling of the main hall. The 2816 seats are divided into the following sections: parquet (bottom), first-tier boxes, second-tier boxes, dress circle, lower balcony, and upper balcony.

tive. In any case, they were ideally located; there was plenty of room in the ceiling for both the troffers and the large ducts they required.

This system was also designed to be much quieter than specified by the acoustician. It has a noise criterion rating of twelve, a full six points below the required minimum. Branch ducts to the 38 troffers are isolated from the trunk ducts with flexible connections; the troffers are attached to the ceiling with angle irons and sheet-metal screws and then sealed with wire mesh and vermiculite plaster. Air directed into the ceiling cools the heat from the lights before it can enter the hall.
